Manhole Inspection Summary

Manhole # S150__027MH

Location Address: **410 BRUNSWICK ST**

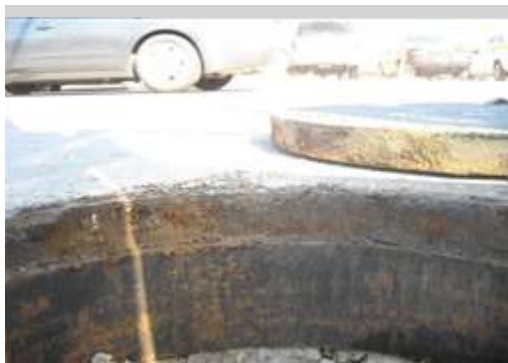
MISC

EVIDENCE OF INFLOW DUE TO SHEETING FROM CROWN OF ROADWAY

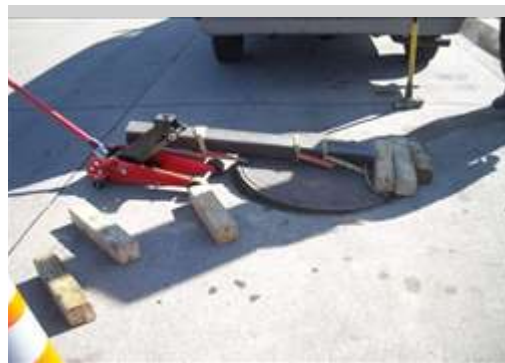
MISC

Comments **OBSERVED 30" SANITARY LID STUCK IN FRAME. USED JACK AND BOLT METHOD TO REMOVE STUCK COVER FROM FRAME. INSPECTION COMPLETE. REPLACED ORIGINAL LID.**

USED JACK/BOLT METHOD TO OPEN STUCK 30" SANITARY LID

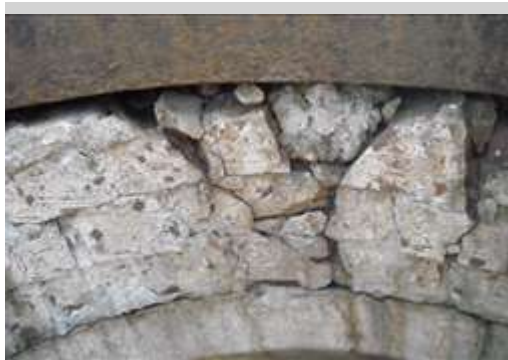
Defect 2

Condition: ☐ Sound ☒ **Cracked** ☐ Root Intrusion ☐ Loose Brick ☒ **Deteriorated**

CRACKED AND DEGRADED CHIMNEY

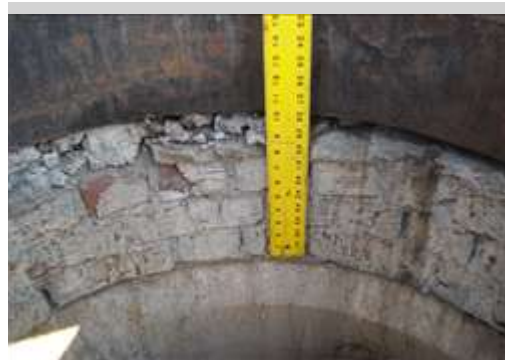
Defect 1

10" PARGED CHIMNEY ADJUSTMENT

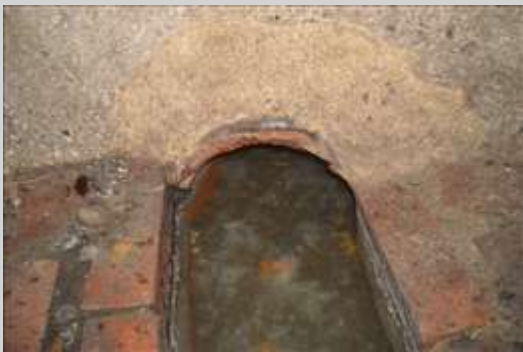
12 O'Clock Outflow

DEBRIS IN CHANNEL

Pipe Height: **10.8** (in.) Rod and Bar (Angled)
Pipe Material: **Clay** ☐ Pipe Lined
Invert Depth: **12.54** (ft.) Flow Characteristics: **Slow**
Deposits: ☐ None ☐ Mud ☐ Sludge ☒ **Debris** ☐ Grease
Silt Depth: **2** (in.) Deposits Extent: **Light**
Infiltration: **None** Pipe Seal Cond: **Sound**
